# Manhole Inspection Summary

Manhole # S02CC2018MH

Insp Date: **6/28/06 2:25 PM**

**Location** Address: **6700 CROSS COUNTRY BLVD**

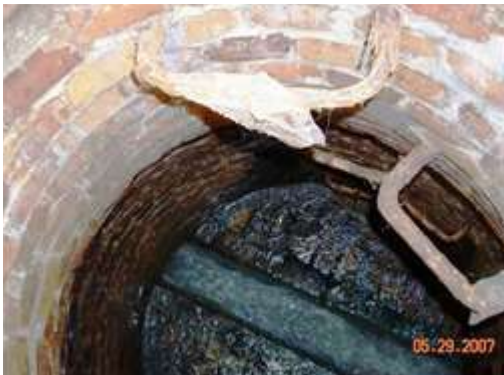
Defect

Evidence of surcharge - Bench debris.  
Adjustment and Corbel infiltration.  
Corroded steps. Bench debris.

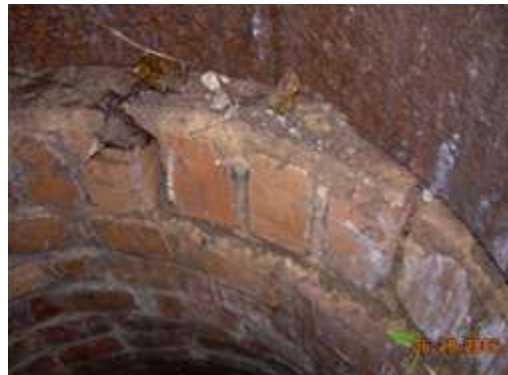
Defect

Frame offset. Adjustment deterioration  
and loose brick. Adjustment infiltration.

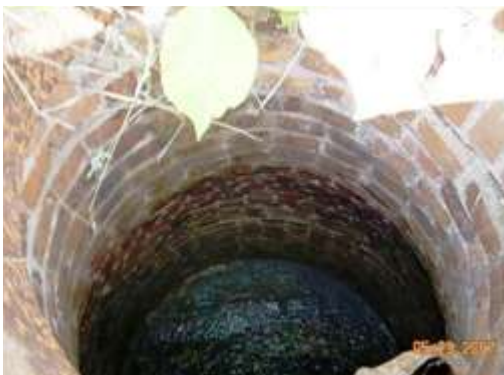
Defect

Adjustment infiltration. Corroded steps.  
Bench debris - other side.

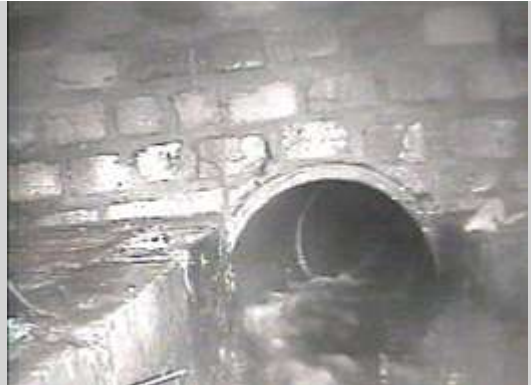
### 12 in. Circular Gravity Sewer Pipe Out @ 12 O'Clock

Infiltration: **Evidence** Pipe Seal Cond: **Cracked**

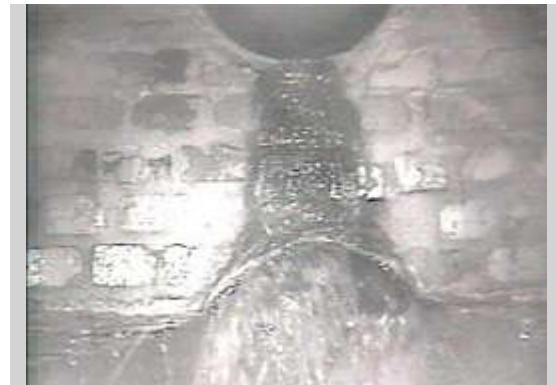
### Drop In @ 6 O'Clock

Turbulent flow, best shot available.

Drop Condition: **Partly Clogged**
